## Deep Energy Retrofit – Case Studies

**Business and Technical Concepts for Deep Energy Retrofit  
of Public Buildings**

**Energy in Buildings and Communities Programme**

**Annex 61, Subtask A**

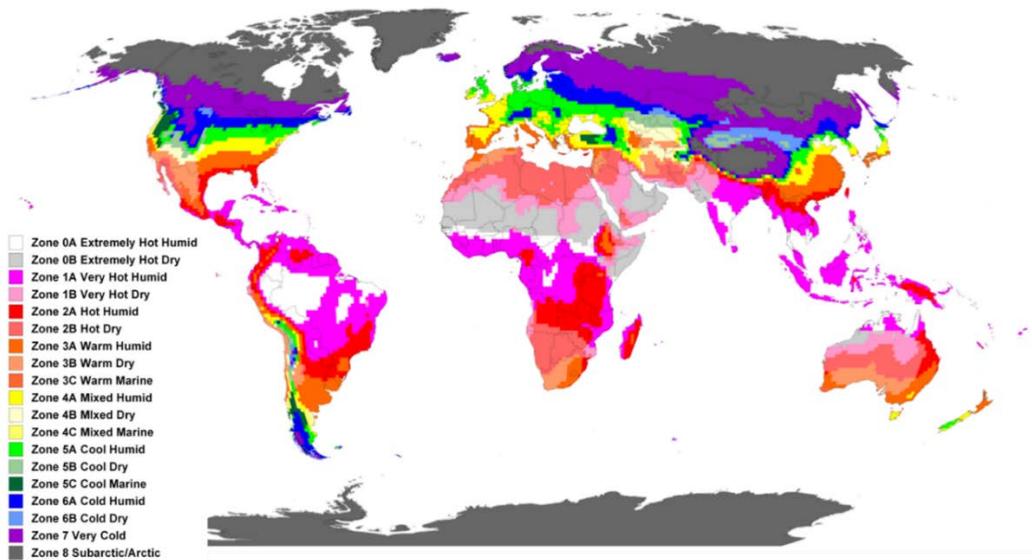
Figure 1-1. Climate Zones Worldwide in Standard 169-2013.

Figure 1-1a shows these broad climate zones for the world. More detail for each country and representative city can be found in Standard 169-2013.

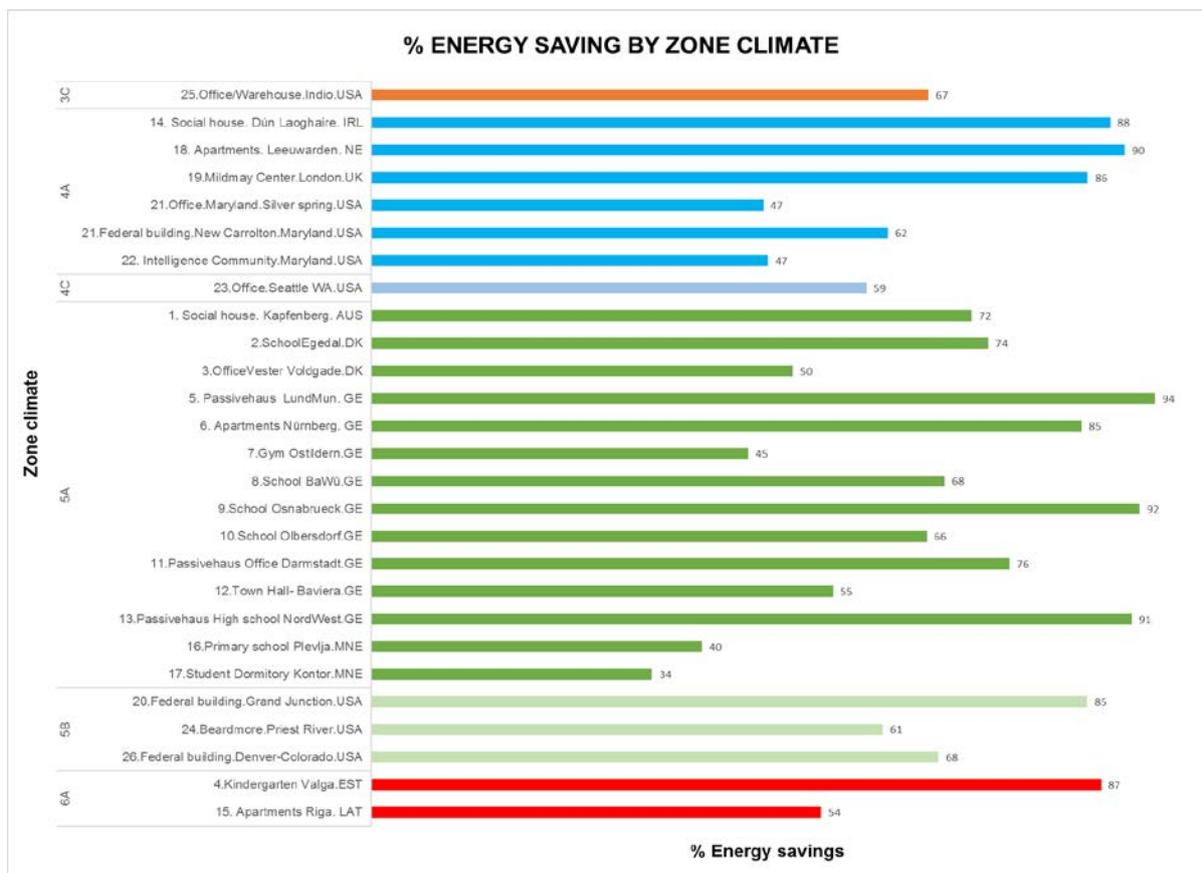
**Figure 1-6. Total energy savings distributed by climate zone.**

When the case studies are sorted by climate zone, it appears that the energy savings for these 26 cases does not show any climate zone dependency. The smallest variation is seen in Climate Zone 5B; however, since there were only three case studies in this climate zone, this cannot be considered statistically significant. The average net energy reduction obtained for all 26 case studies was 66.4%.

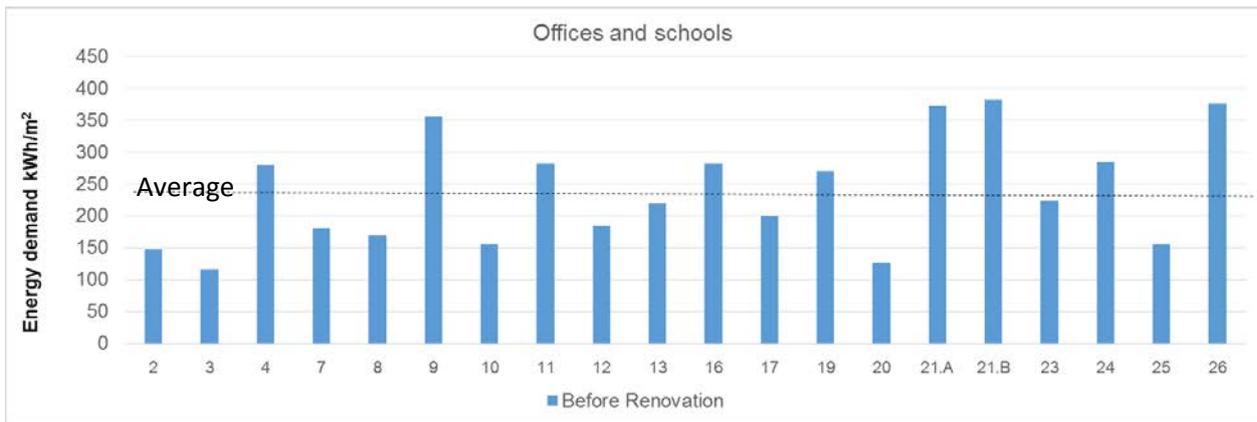
Figure 1-7. Energy Use Intensity pre-DER for Public buildings, average: 238 kWh/m<sup>2</sup>; Case 22 is not displayed.

The Energy Use Intensity (EUI) of the case studies before Deep Energy Renovation was plotted for offices and schools (Figure 1-7) and for multifamily houses (Figure 1-8). The average EUI in the evaluated public buildings is 238 kWh/m<sup>2</sup>. The EUI case study No. 22 resulted from the change in building footage. Some buildings such as 9, 21A, 21B, 28

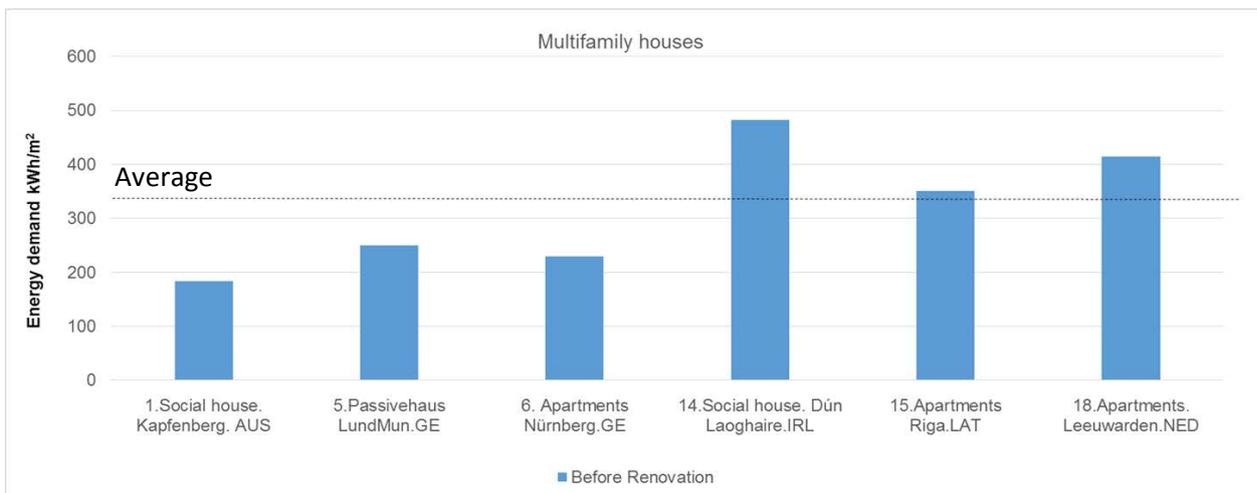
Figure 1-8. Energy Use Intensity pre-DER of family houses; average: 319 kWh/m.

Figure 1-8 shows that the average ex-ante DER EUI in residential buildings is 319 kWh/m<sup>2</sup>, which is 80 kWh/m<sup>2</sup> higher than that of the public buildings and may be related to the higher usage in residential buildings. The evaluation shows that over- average EUI are found at residential buildings equipped with individual oil/gas boilers with auxiliary electrical heaters; those below or close to average values are connected to district heating systems.

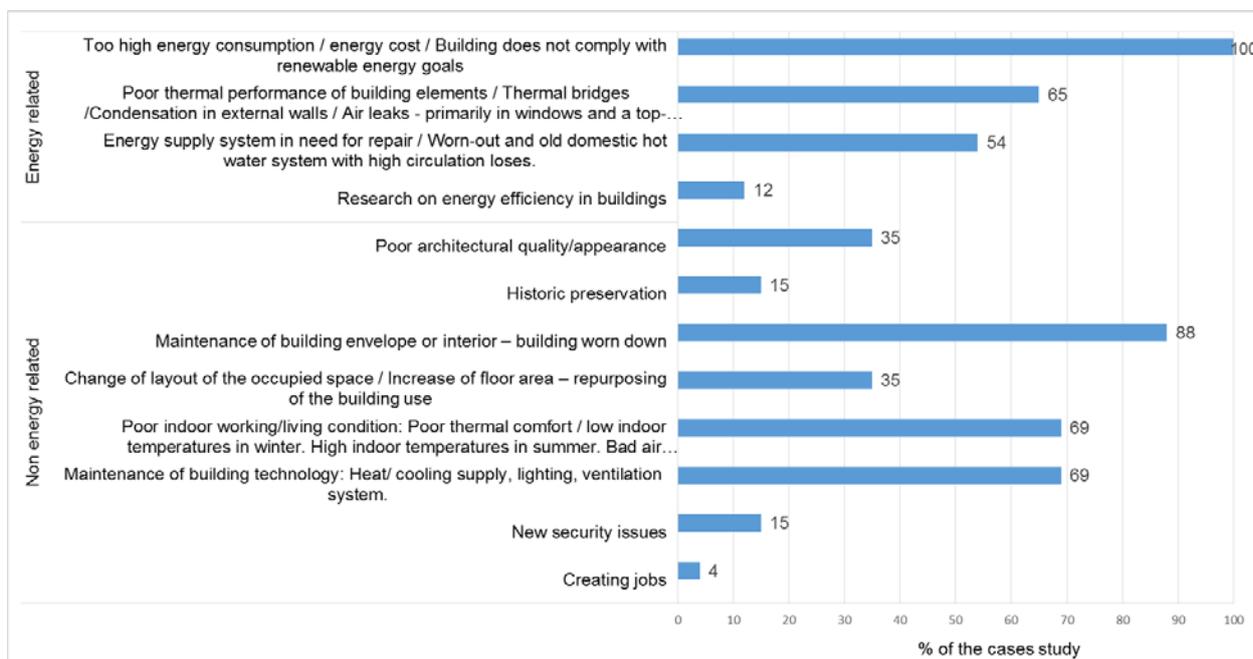
Figure 1-9. Reasons for renovation (% of the cases studies); Co-benefits of DER

The observed reasons for undertaking a renovation were categorized in two main groups: energy related and non-energy related. In Figure 1-9, the number to the right of each horizontal bar indicates the percentage of the case studies that undertook energy retrofits for the listed reason.

Clearly, the greatest non-energy-related reason for carrying out retrofits (88%) is “general maintenance.” This high percentage is of particular interest in that most of the case studies were not renovated solely to **save energy**, but rather to catch up with a backlog of maintenance and refurbishment, some of which were energy-related such as “poor thermal performance,” “energy system in need for repair,” etc. This indicates that many of the renovation measures had to be implemented to maintain the building and its functionality.

These reasons shown in Figure 1-9 are obviously related to some extent. All 26 case studies were renovated for a combination of reasons, some energy related and some not. This supports a “rule of thumb” for energy renovation, that it always makes sense to consider DER when a building is undergoing renovation anyway.

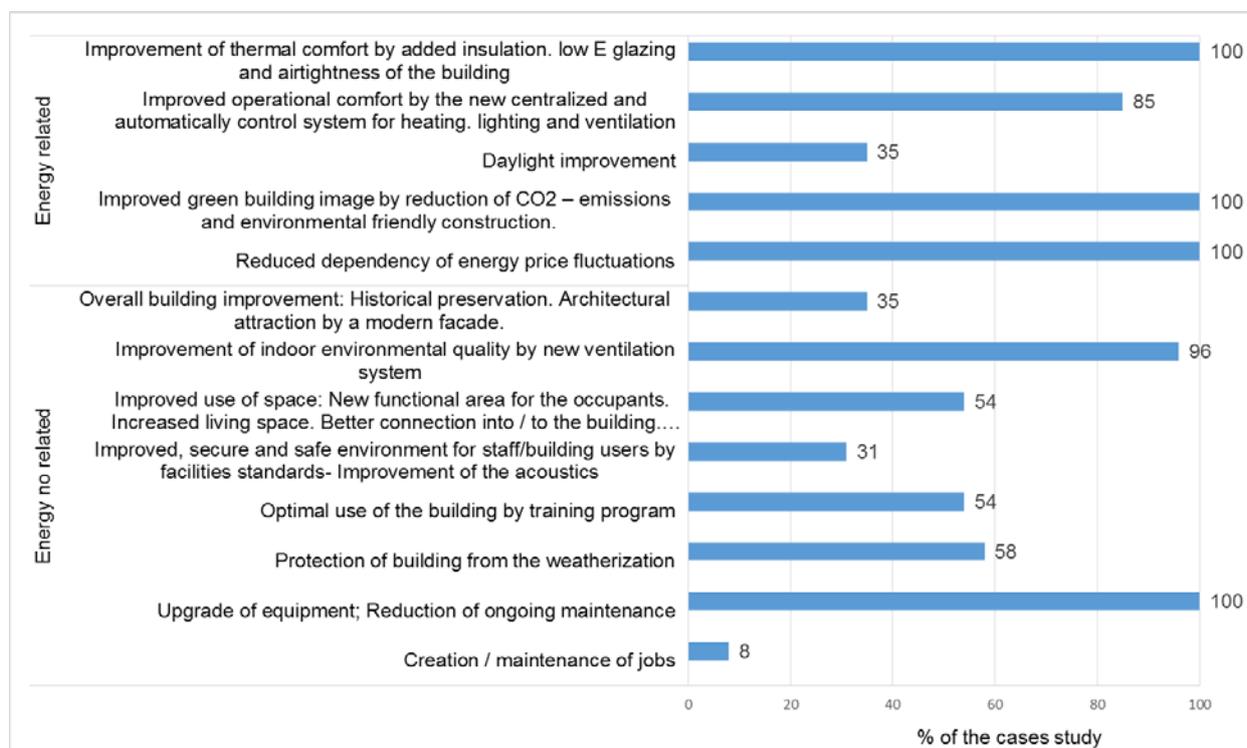
Figure 1-10. Energy-related and non-energy-related co-benefits (% of the cases studies).

The co-benefits of DER can also be categorized into energy- and non-energy related. The histogram in Figure 1-10 clearly shows that three of the energy-related co-benefits (improvement of thermal comfort, improved green building image, and reduced dependency of fuel price variations) were identified in all case studies. Additionally, in 85% of the cases, an improved operational comfort of the building automation system was observed.

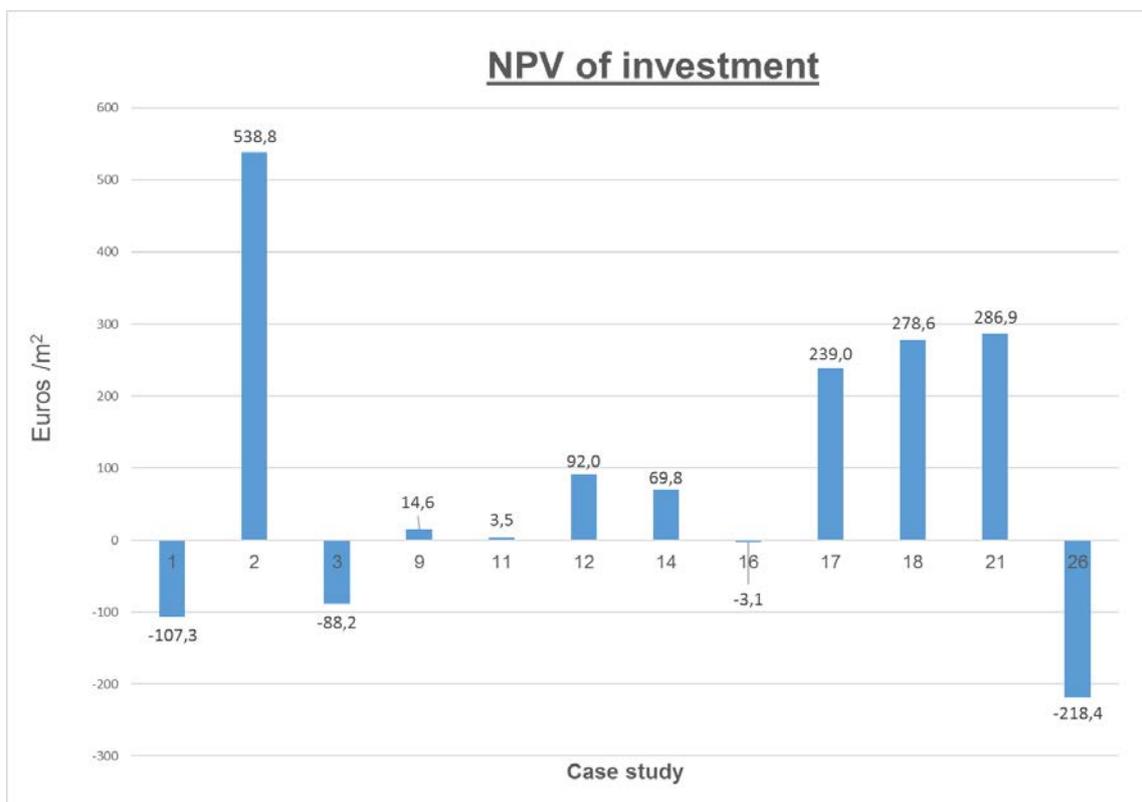
**Figure 1-11. Net present value of 12 case studies calculated with rates for discount and inflation equal to 2%.**

To generate an overall picture, NPV was calculated for each case study that could provide plausible investment costs, energy, and other cost savings. The calculation used the same discount rate for all the cases (2%). The expected economic and technical lifetime was set to 30 years. The calculation did not account for maintenance and replacement costs for some of the components implemented such as building automation, heating pumps, engines etc. Twelve of the 26 case studies presented sufficient information for this calculation (Figure 1-11).

A positive NPV signals that cost effectiveness is achieved over the 30-year time period, while a negative NPV shows that cost effectiveness is not achieved in this period.

Three-fourths of the case studies are cost effective within the given framework conditions. Figure 1-11 also shows that there is a large variation between these 12 case studies. For Case Study No. 2, the NPV was as high as 538.80 Euro/m<sup>2</sup>; for Case Study No. 26, it was 218.40 Euro/m<sup>2</sup>. This reflects the fact that the investments costs vary widely. It may also reflect an issue already mentioned above, that for those case studies that exhibit high, positive NPV

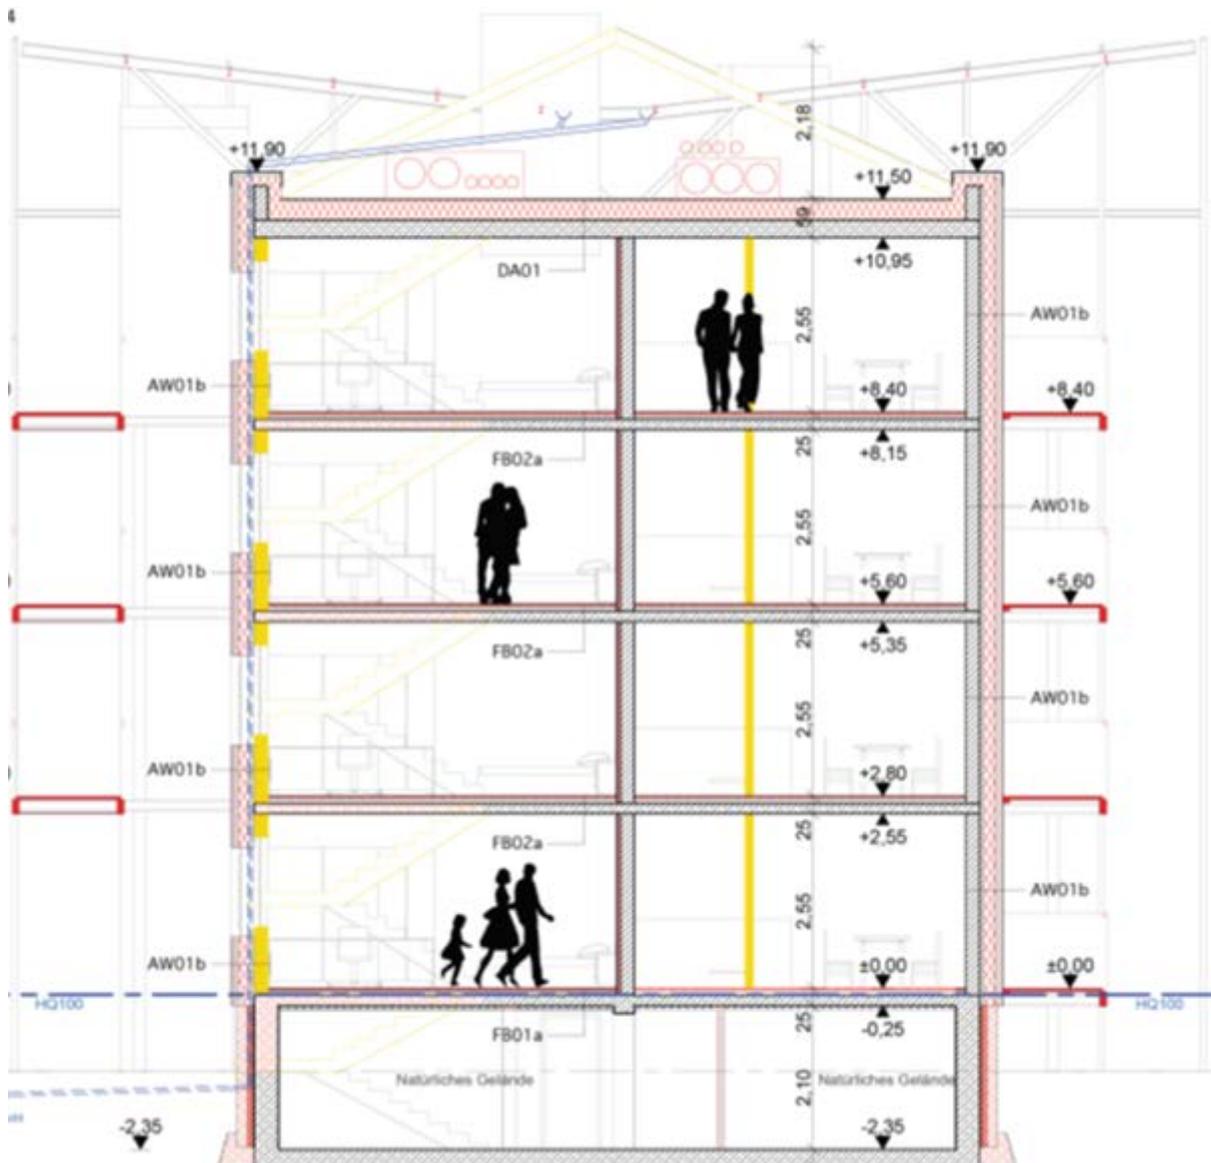
Figure A-5. Cross section of the renovated building.

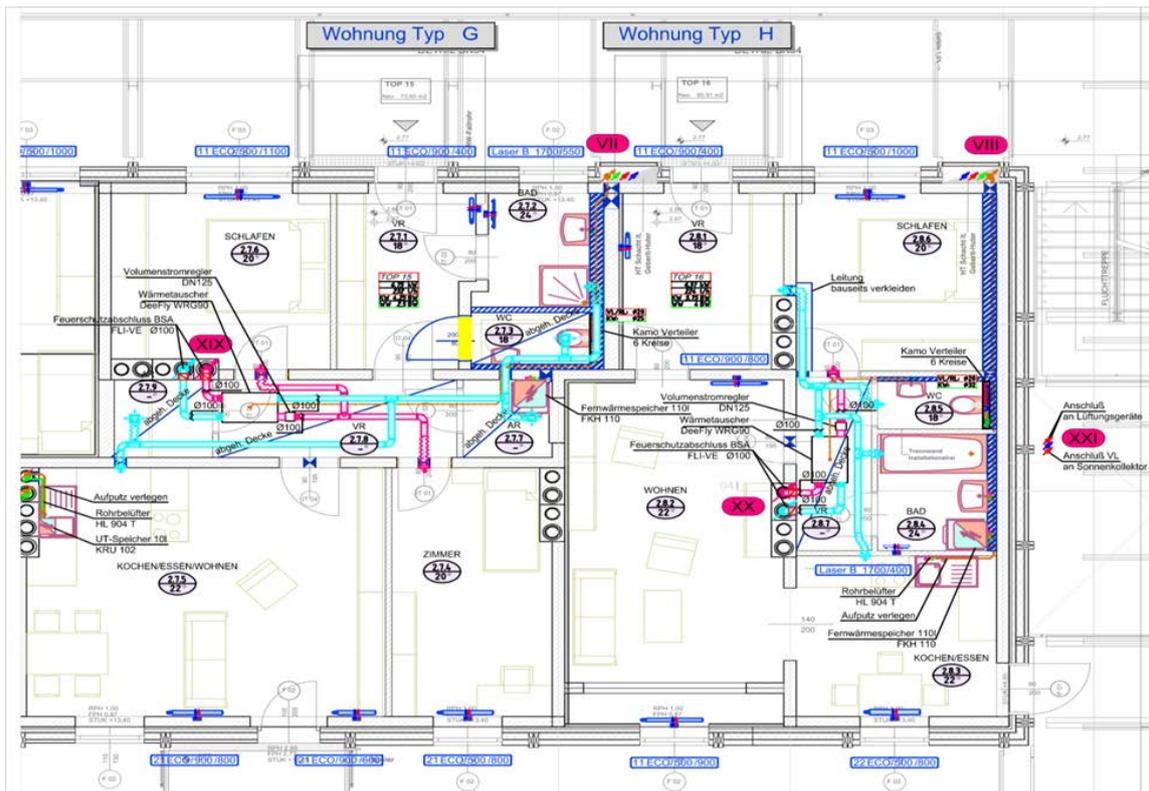
Figure A-11. Ventilation scheme.

In one half of the flats the ventilation system is controlled automatically based on the CO<sub>2</sub> concentration; in the other half of the flats, the residents can control the ventilation system manually by a three-stage switch.

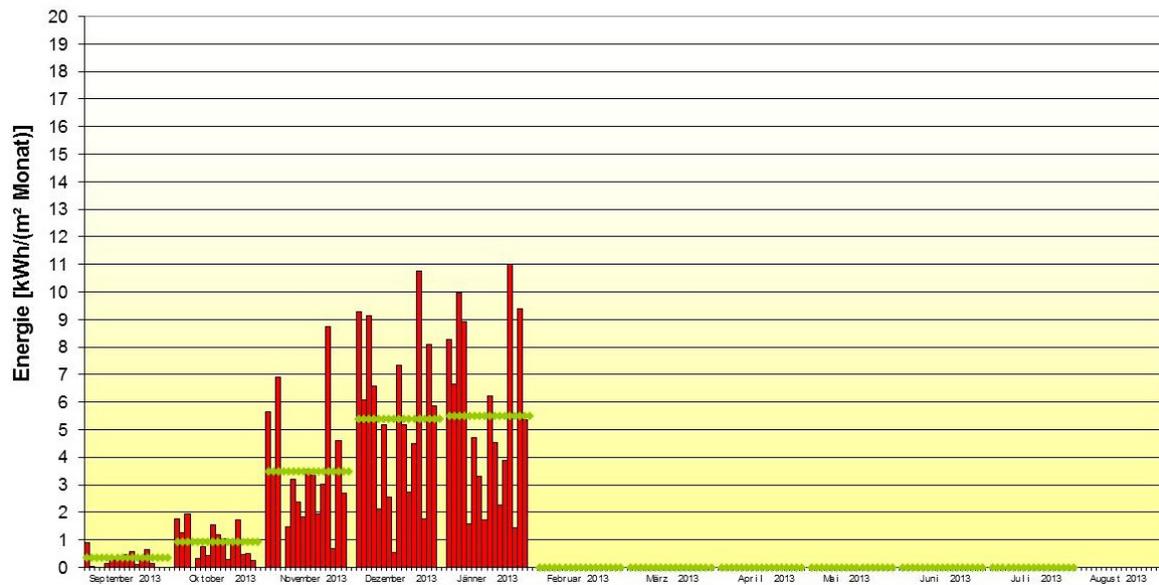
**Figure A-13. Energy consumption for space heating, month values of measured flats (monitoring period September 1, 2013 – January 31, 2014).**

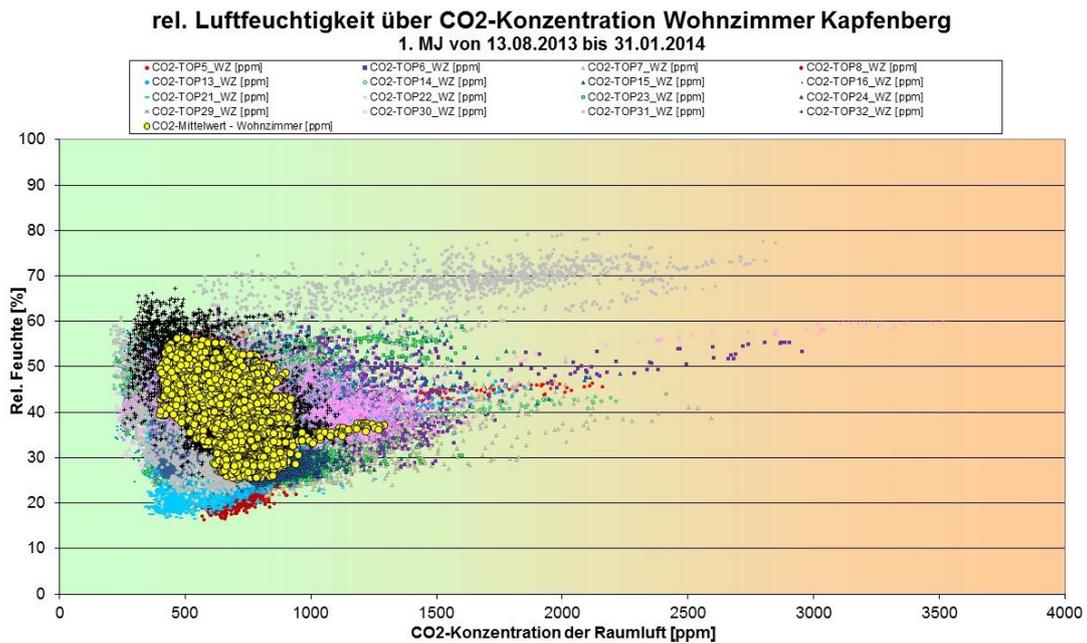
Figure A-15. CO<sub>2</sub> concentration/humidity of measured flats, monitoring period 01.09.2013 – 31.01.2014.

- CO<sub>2</sub> concentration in almost all flats is under 1000 ppm.
- Humidity in flats is between 20% – 60%.
- In all flats indoor temperature is in the range of comfort requirements (Austrian standards).

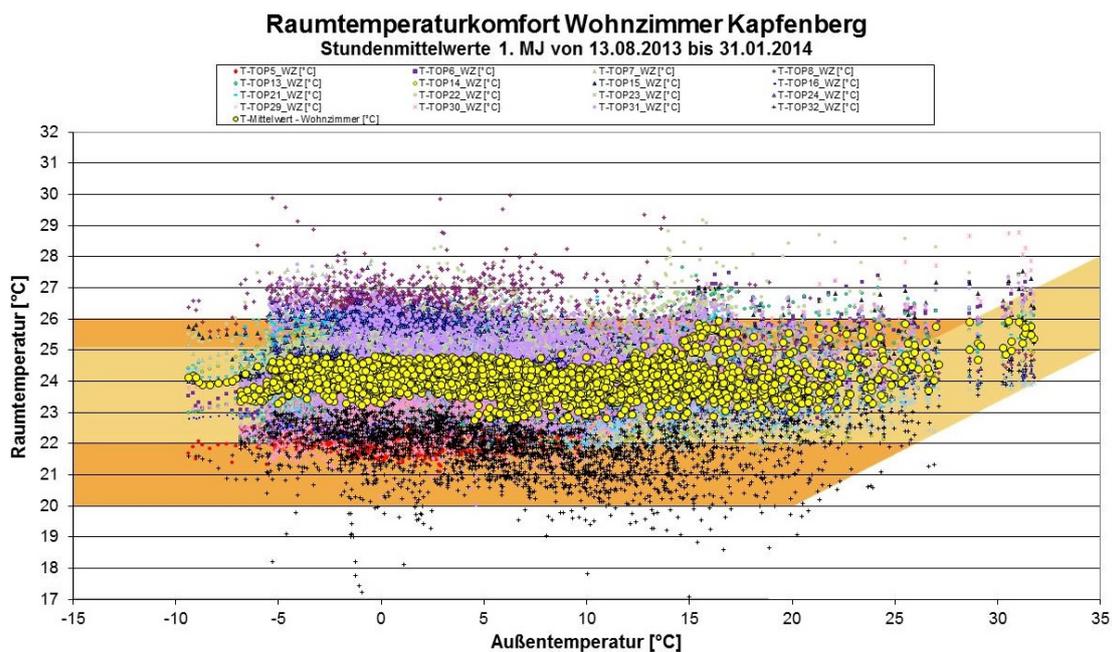
Figure A-16. Indoor temperature/outdoor of measured flats (living rooms) (monitoring period September 1, 2013 – January 31, 2014).

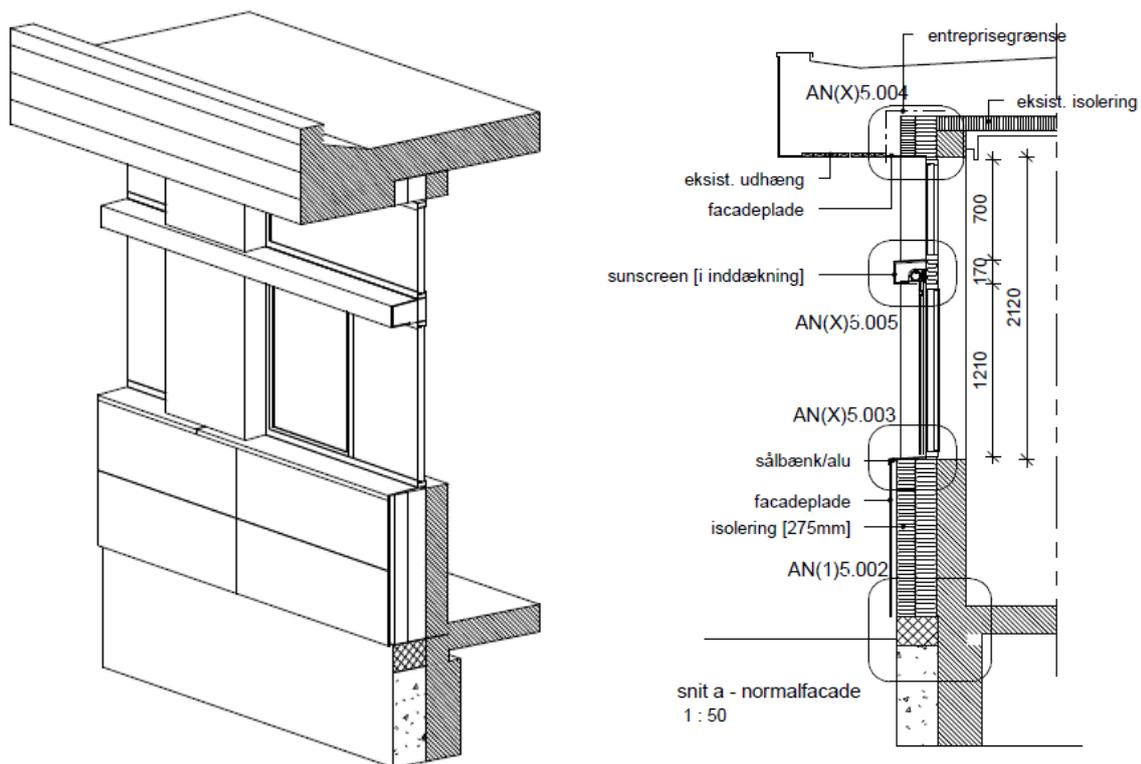
Figure B-14. Cross section of renovated facade.

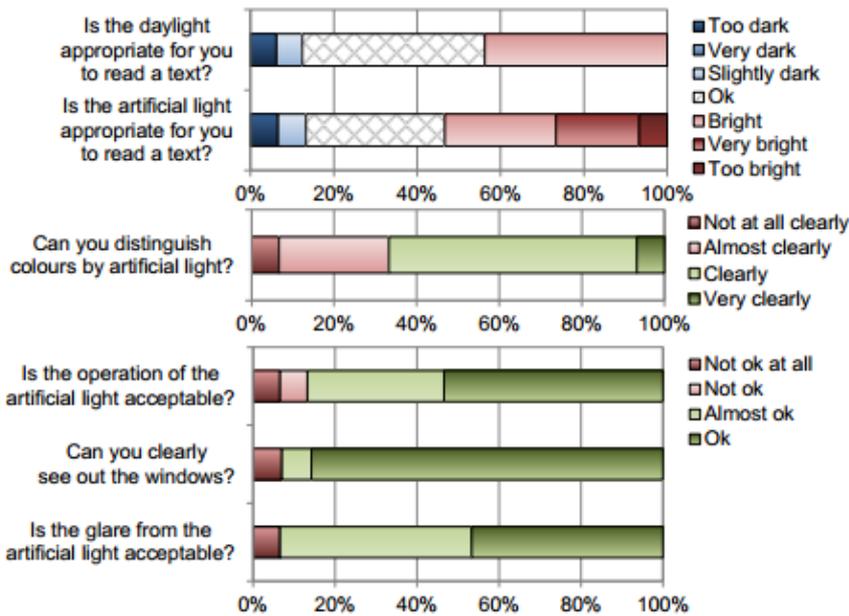
Figure B-17. Room 40 before renovation, students' assessment of the daylight and artificial light conditions.

The students indicated a high degree of satisfaction with the issues of 'operation of the artificial light', 'glare from the artificial light', and 'ability to see out of the windows'. Figures B-17 and B-18 show the Room 40 survey results before and after the renovation.

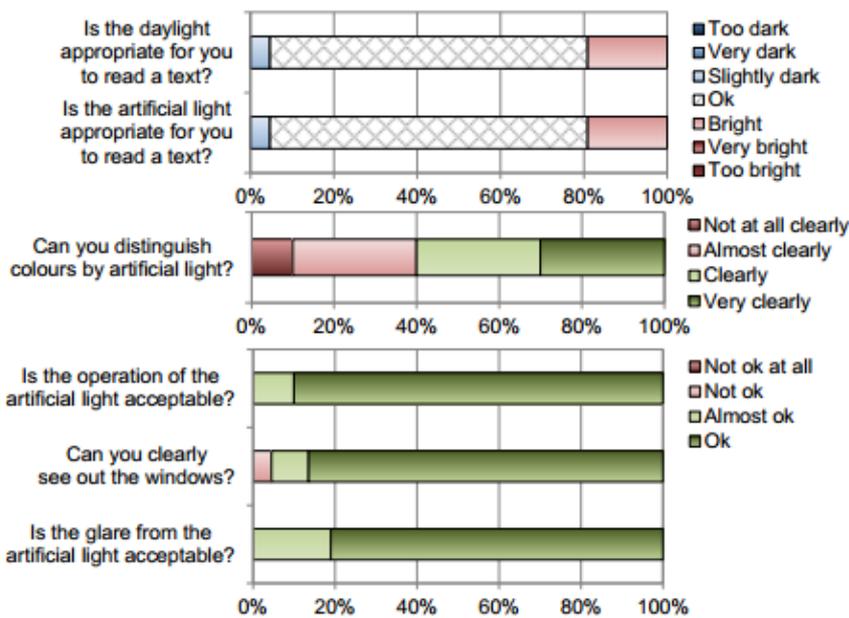
Figure B-18. Room 40 after renovation, students' assessment of the daylight and artificial light conditions.

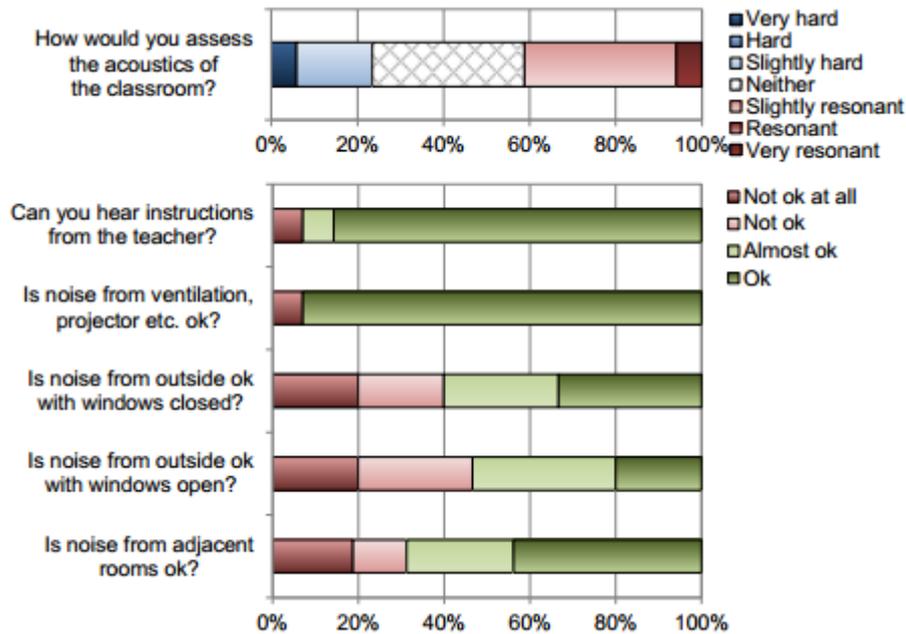
Figure B-19. Room 40 before renovation, students’ assessment of acoustics and noise in the classroom.

to hear instructions from the teacher’, ‘noise from ventilation, projector etc.’, ‘noise from outside (windows open)’, ‘noise from outside (windows closed) and ‘noise from adjacent rooms’ generally indicate improved conditions and generally a high degree of satisfaction, as it can be seen Figures B-19 and B-20. One exception, though, is in Room 58 where ‘noise from adjacent rooms’ apparently has worsened significantly after the renovation. Before the renovation about 10% of the students found the conditions ‘not ok’ whereas after the renovation 60% finds the conditions ‘not ok’.

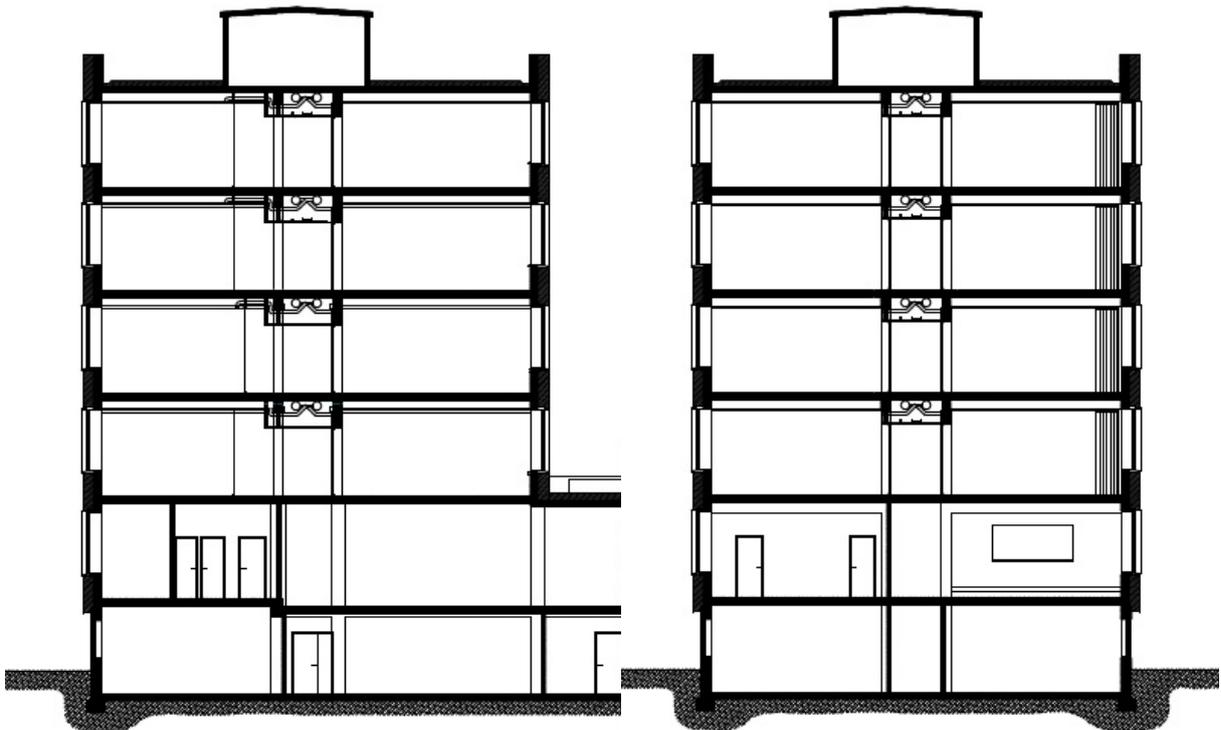
Figure B-32. Cross section A-A.

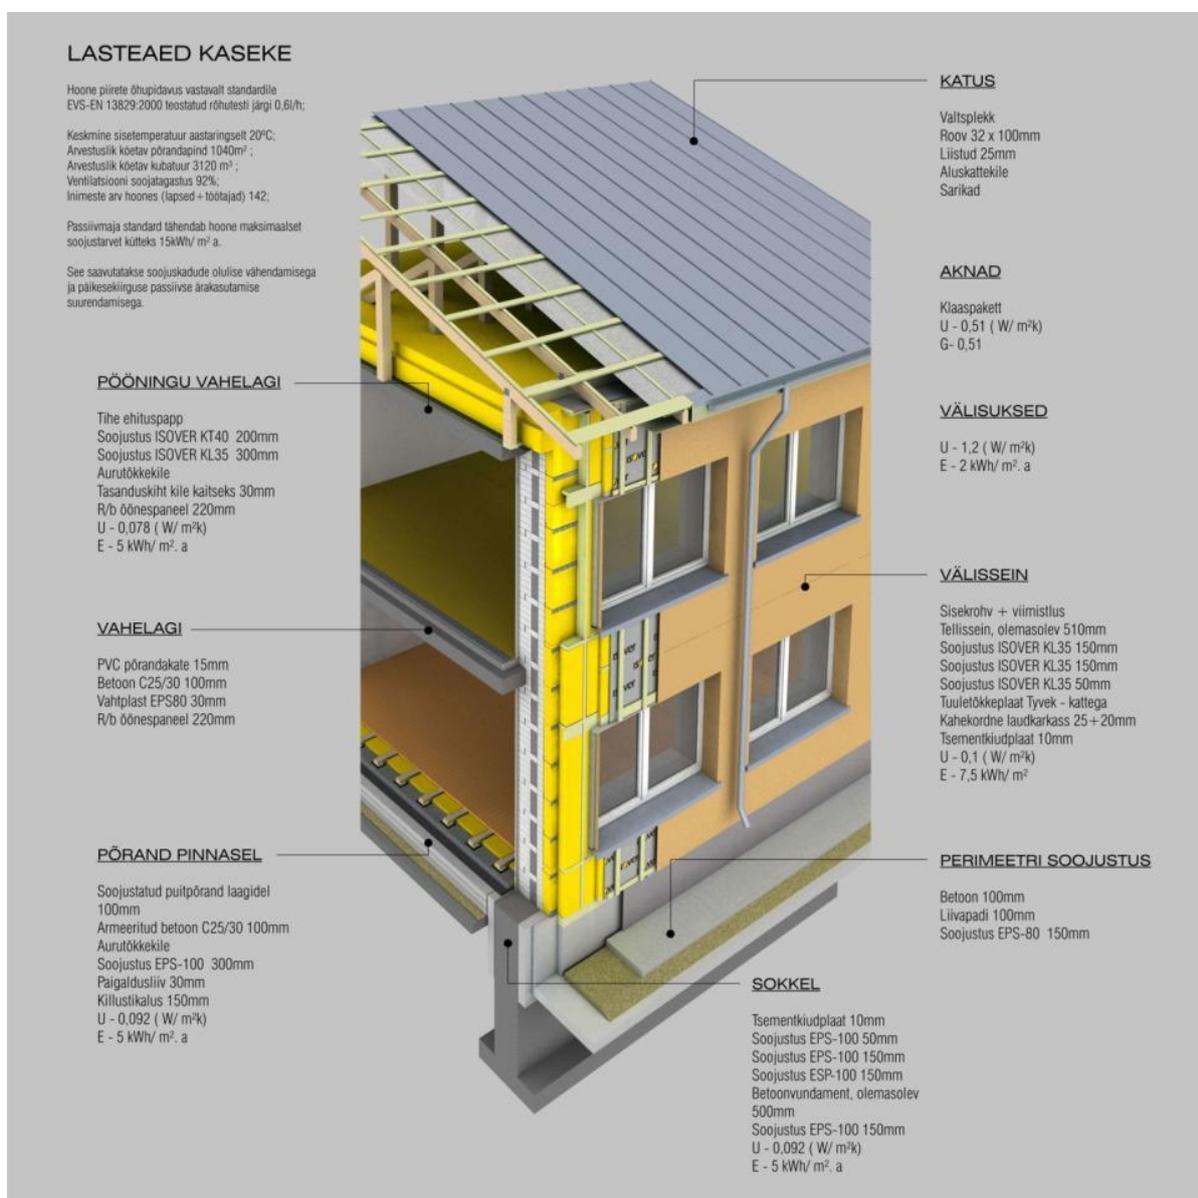
Figure C-14. Basic refurbishment concept – well insulated, thermal-bridge free and airtight envelope.

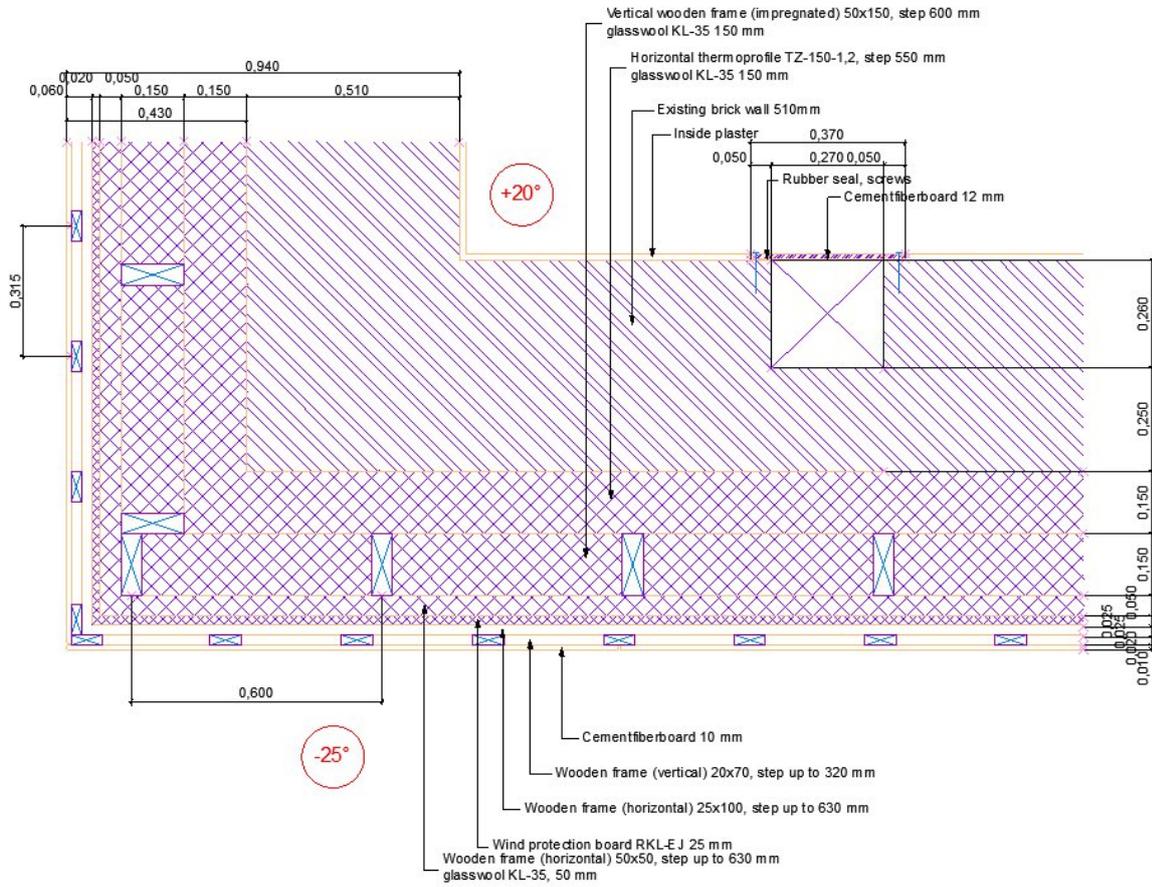
Figure C-18. Designed wall.

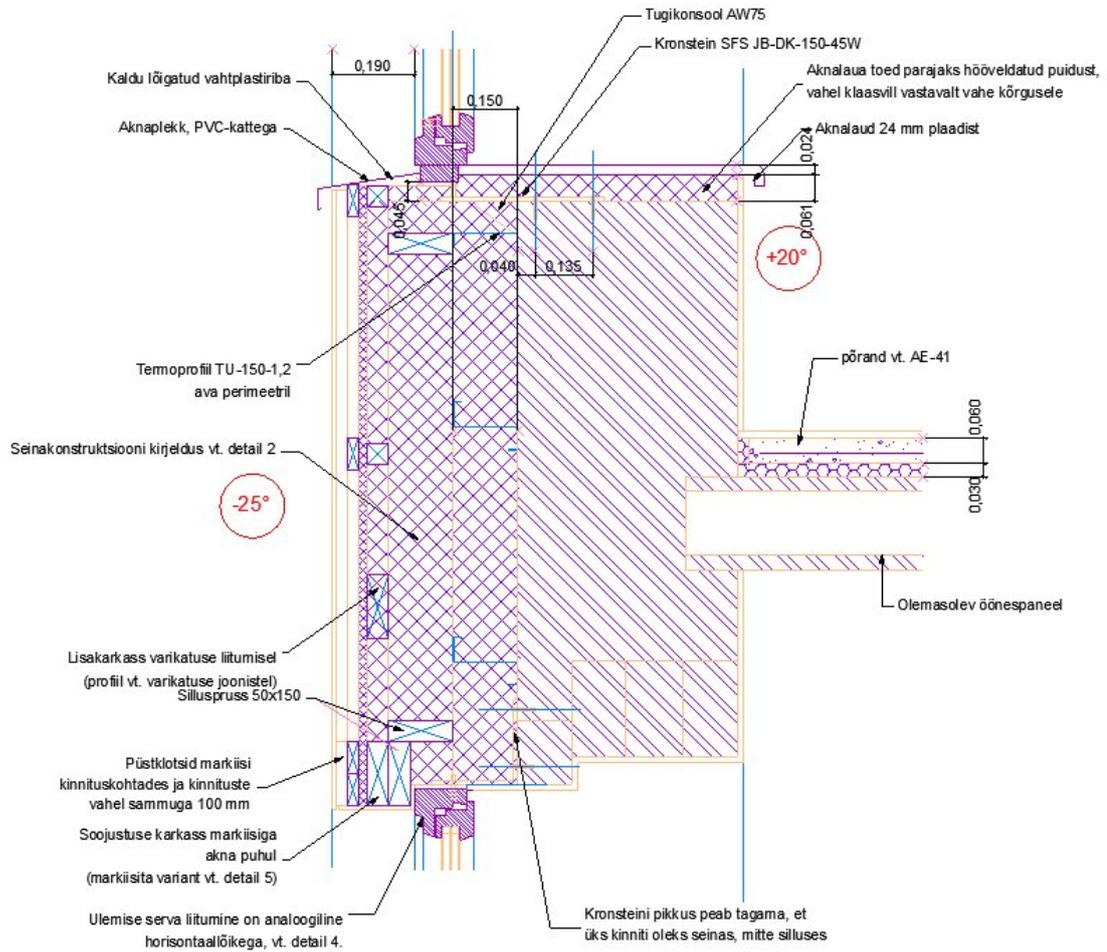
Figure C-19. Designed window connection.

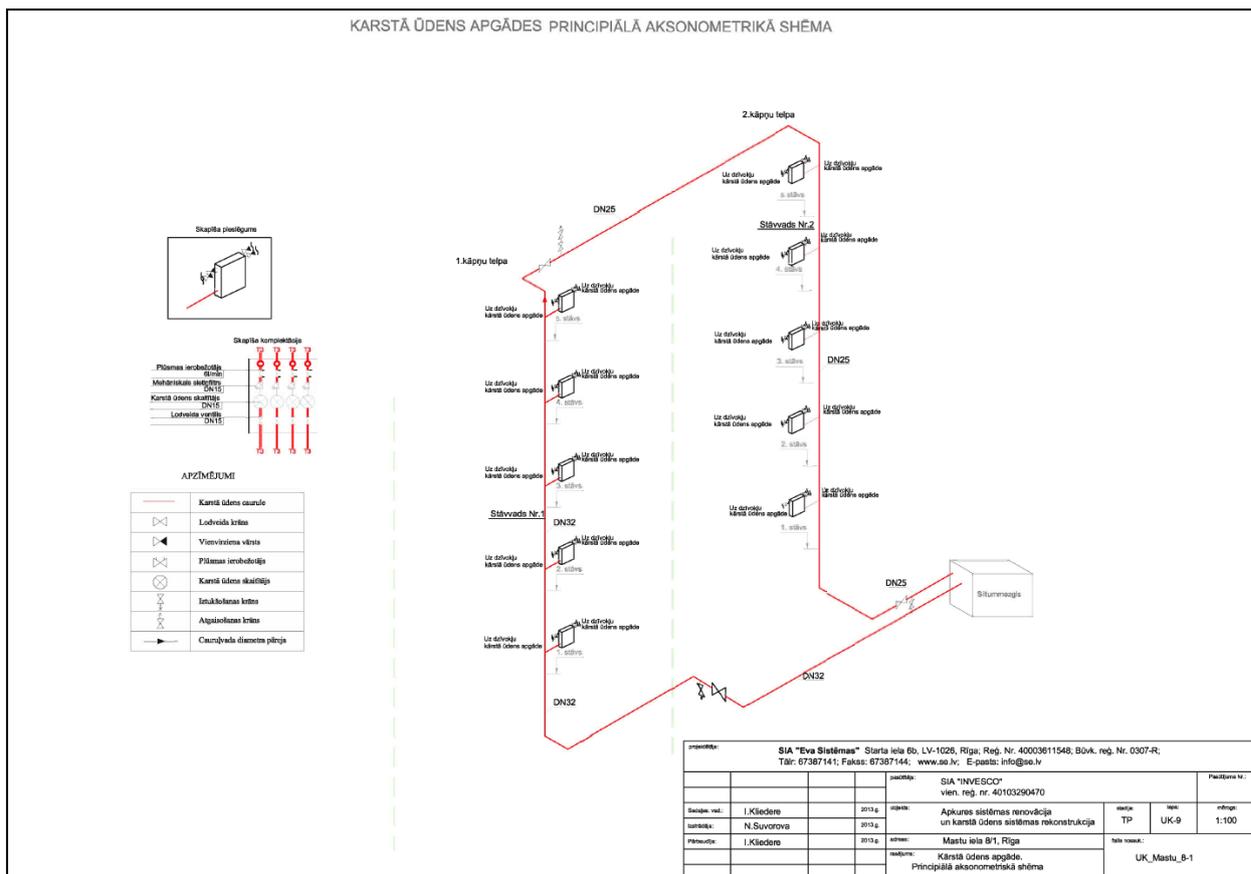
Figure F-3. Axonometric scheme of new domestic hot water system.

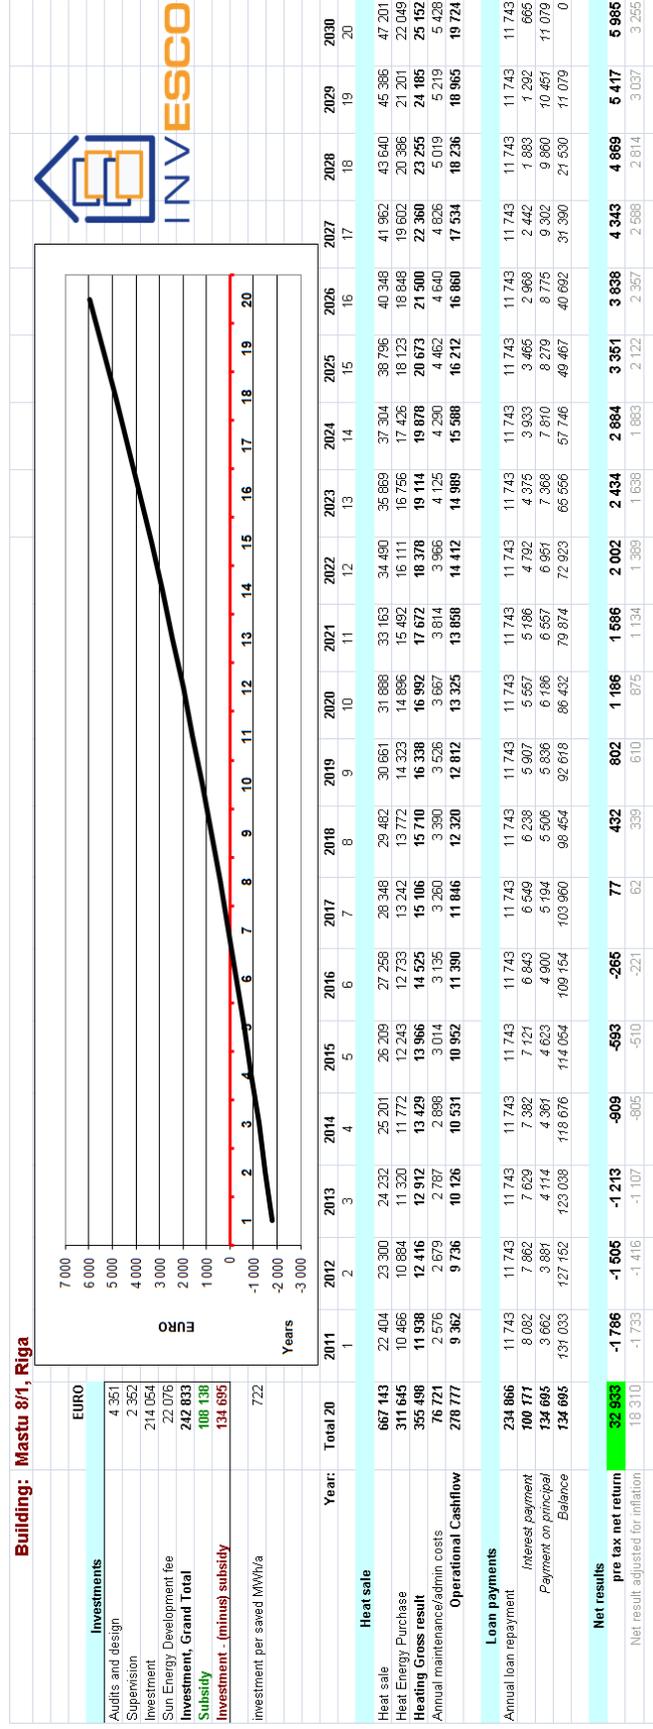
Figure F-5. Cost effectiveness.

Cost effectiveness is considered to include that description of framework data such as calculated interest rates, life cycle period, etc. Figure F-5 shows the results of an investment and financial simulation.

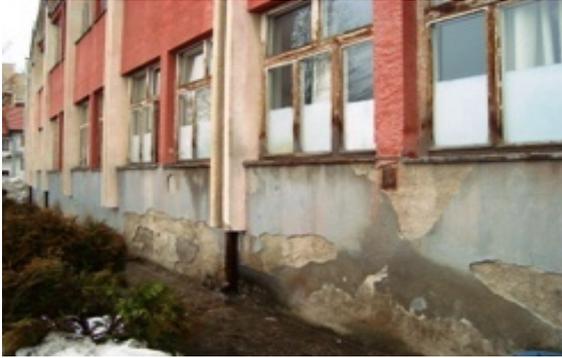
**Figure G-9. Damages on the facade.**

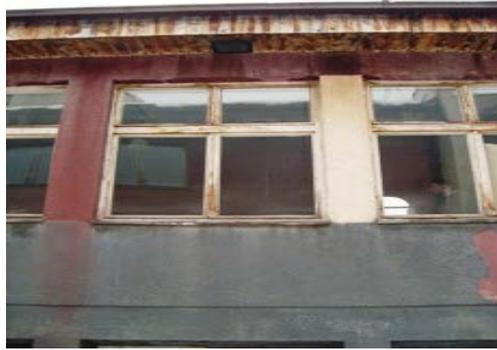
**Figure G-10. Damages on the flashing on roof eaves.**

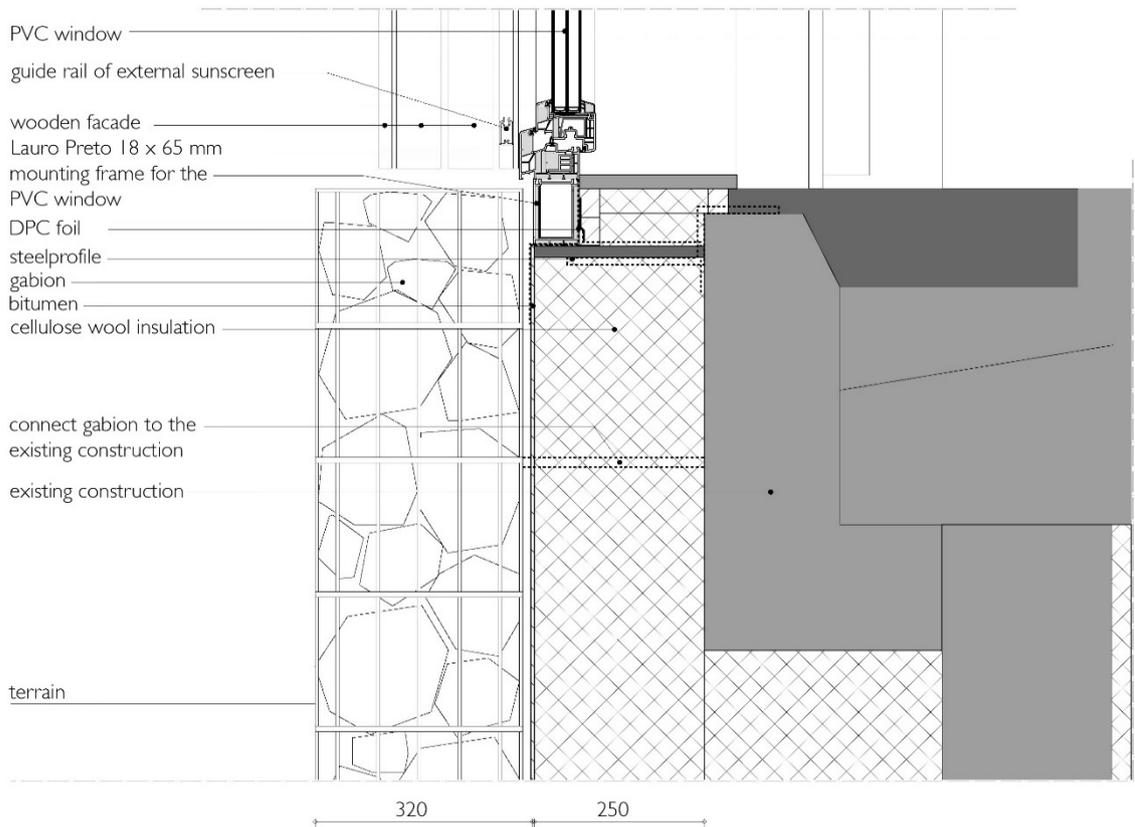
**Figure H-10. Key junction of window with terrane in ground floor.**
