## Deep Energy Retrofit – Case Studies

**Business and Technical Concepts for Deep Energy Retrofit  
of Public Buildings**

**Energy in Buildings and Communities Programme**

**Annex 61, Subtask A**

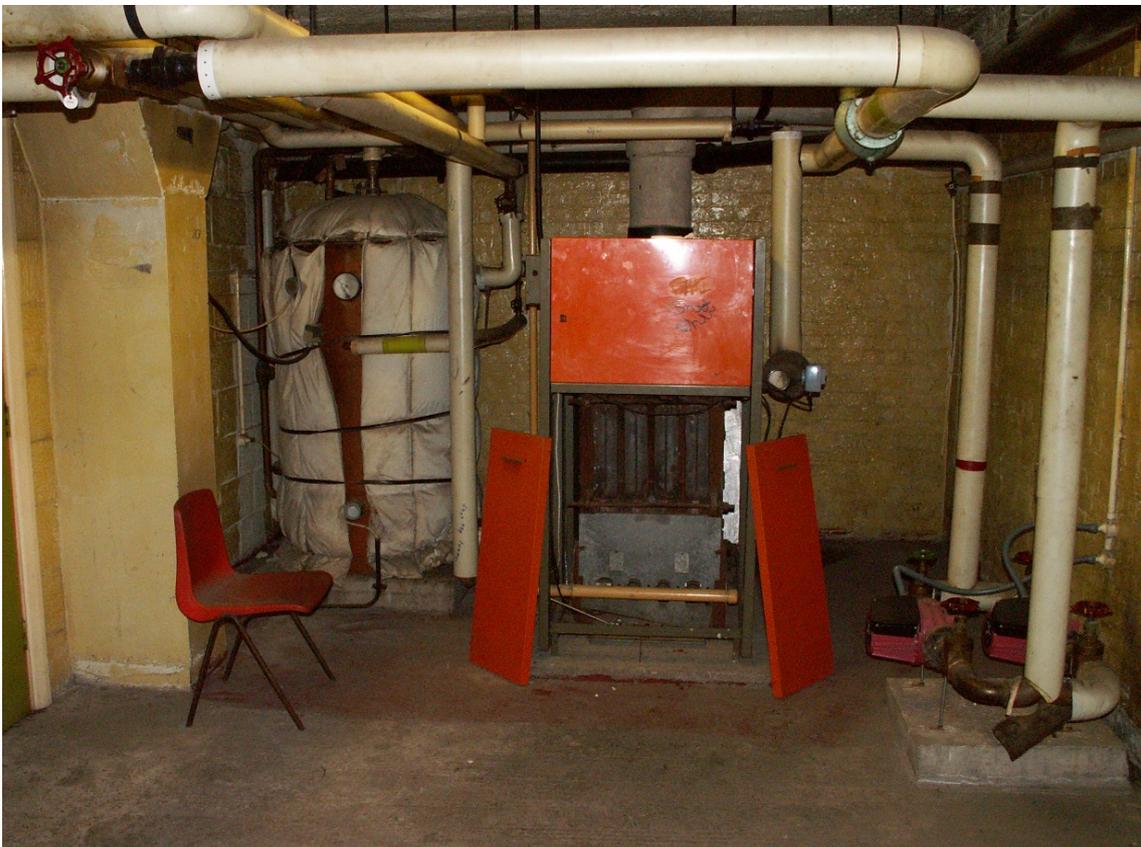
Figure I-5. Before retrofit: Boiler room.

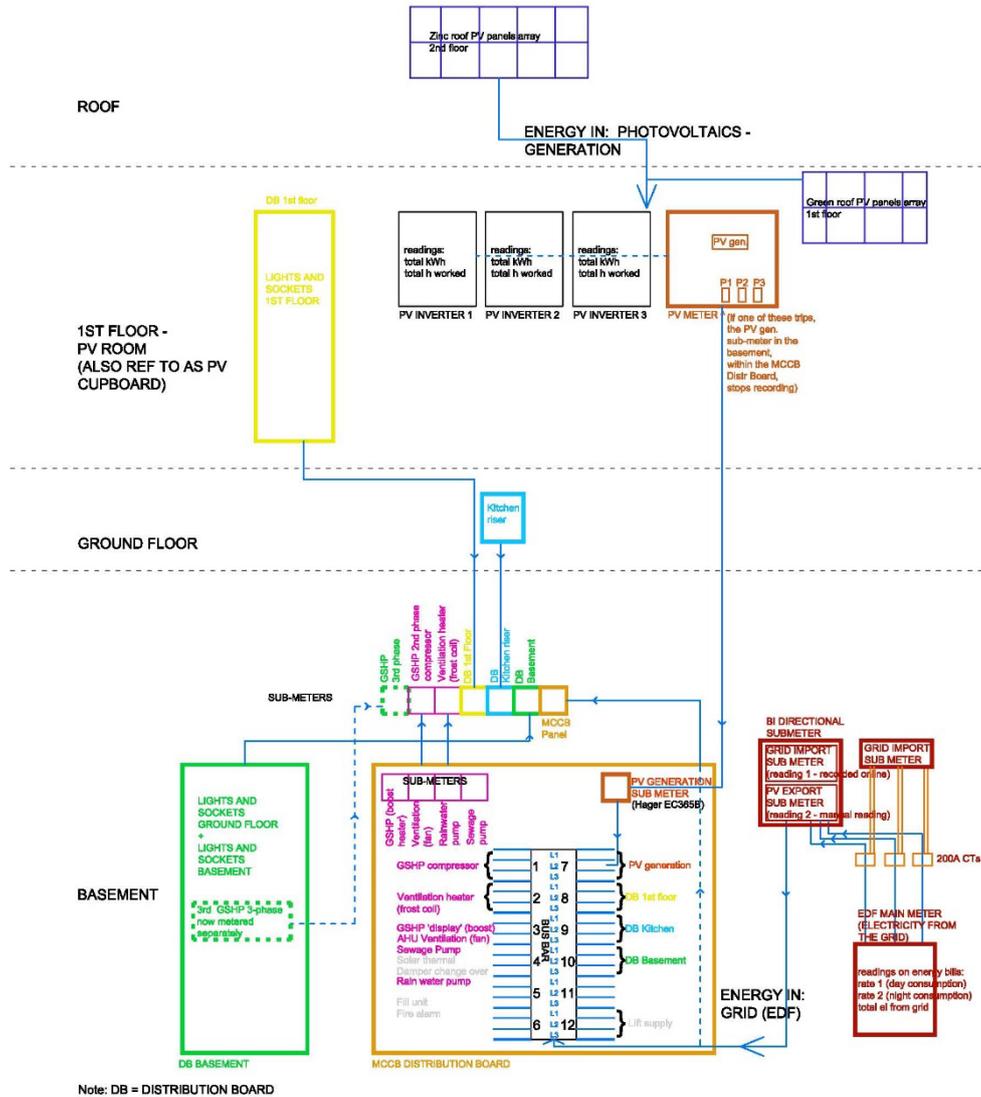
Figure I-15. Schema of energy services.

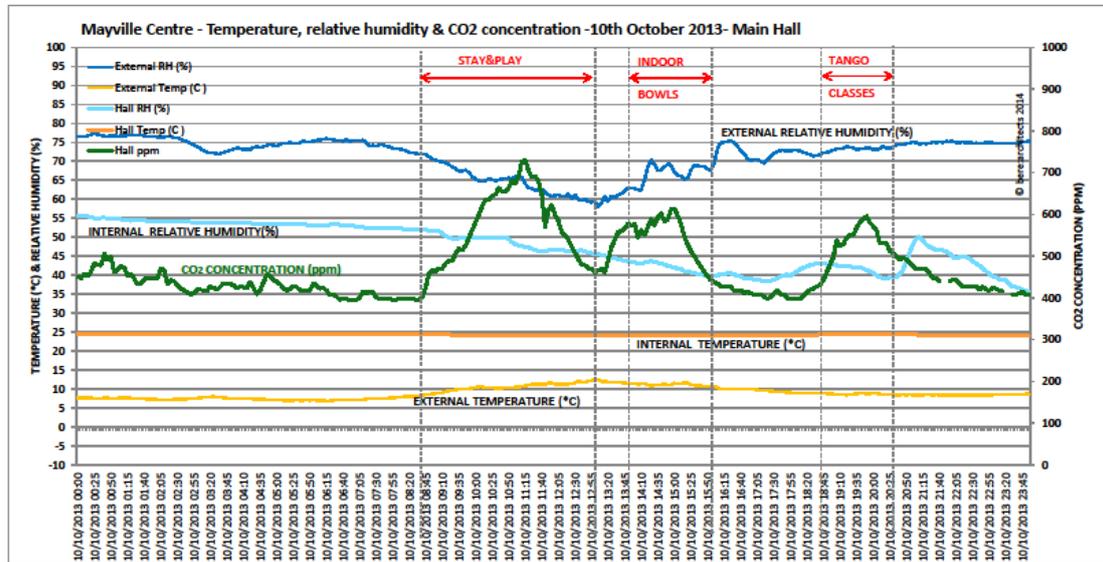
- Very high air quality has been found to be maintained throughout the building at all times.
- Graph below shows air quality study on a typical day of occupancy in the main hall.

Figure I-21. Monitors air quality.

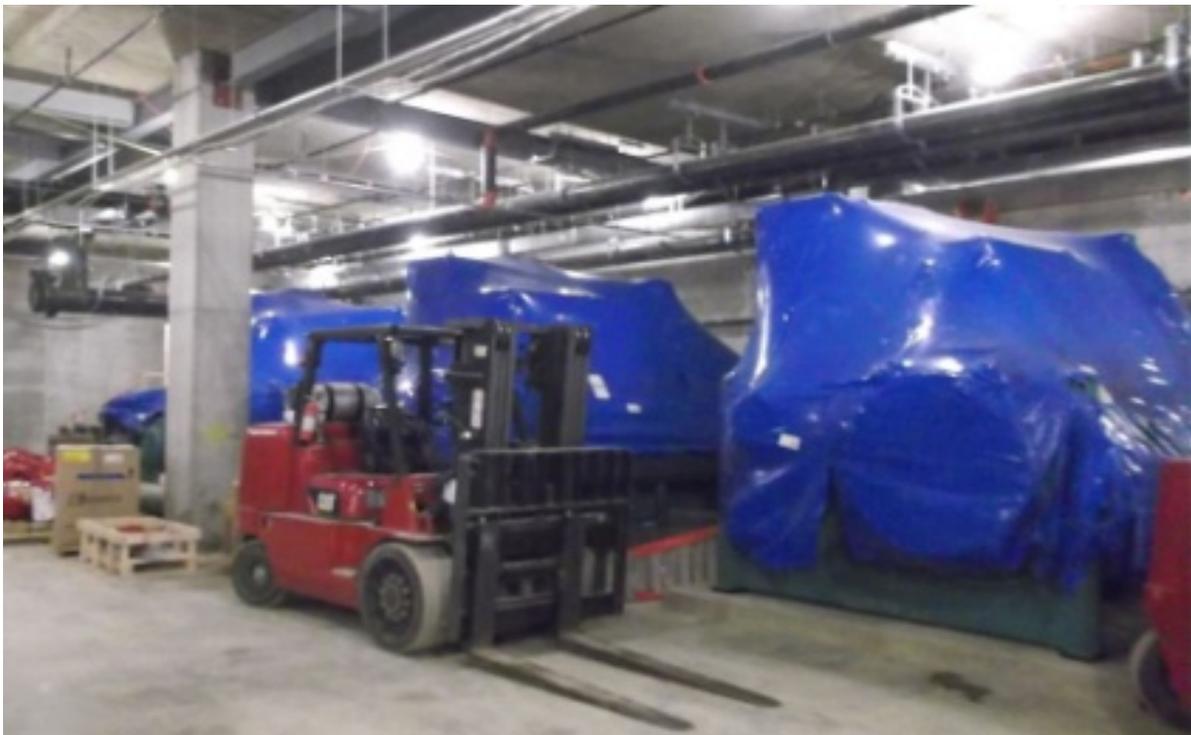
Figure J-27. CMP chillers.
